Welcome to the Manx Mining Trail

Beckwith's Mine

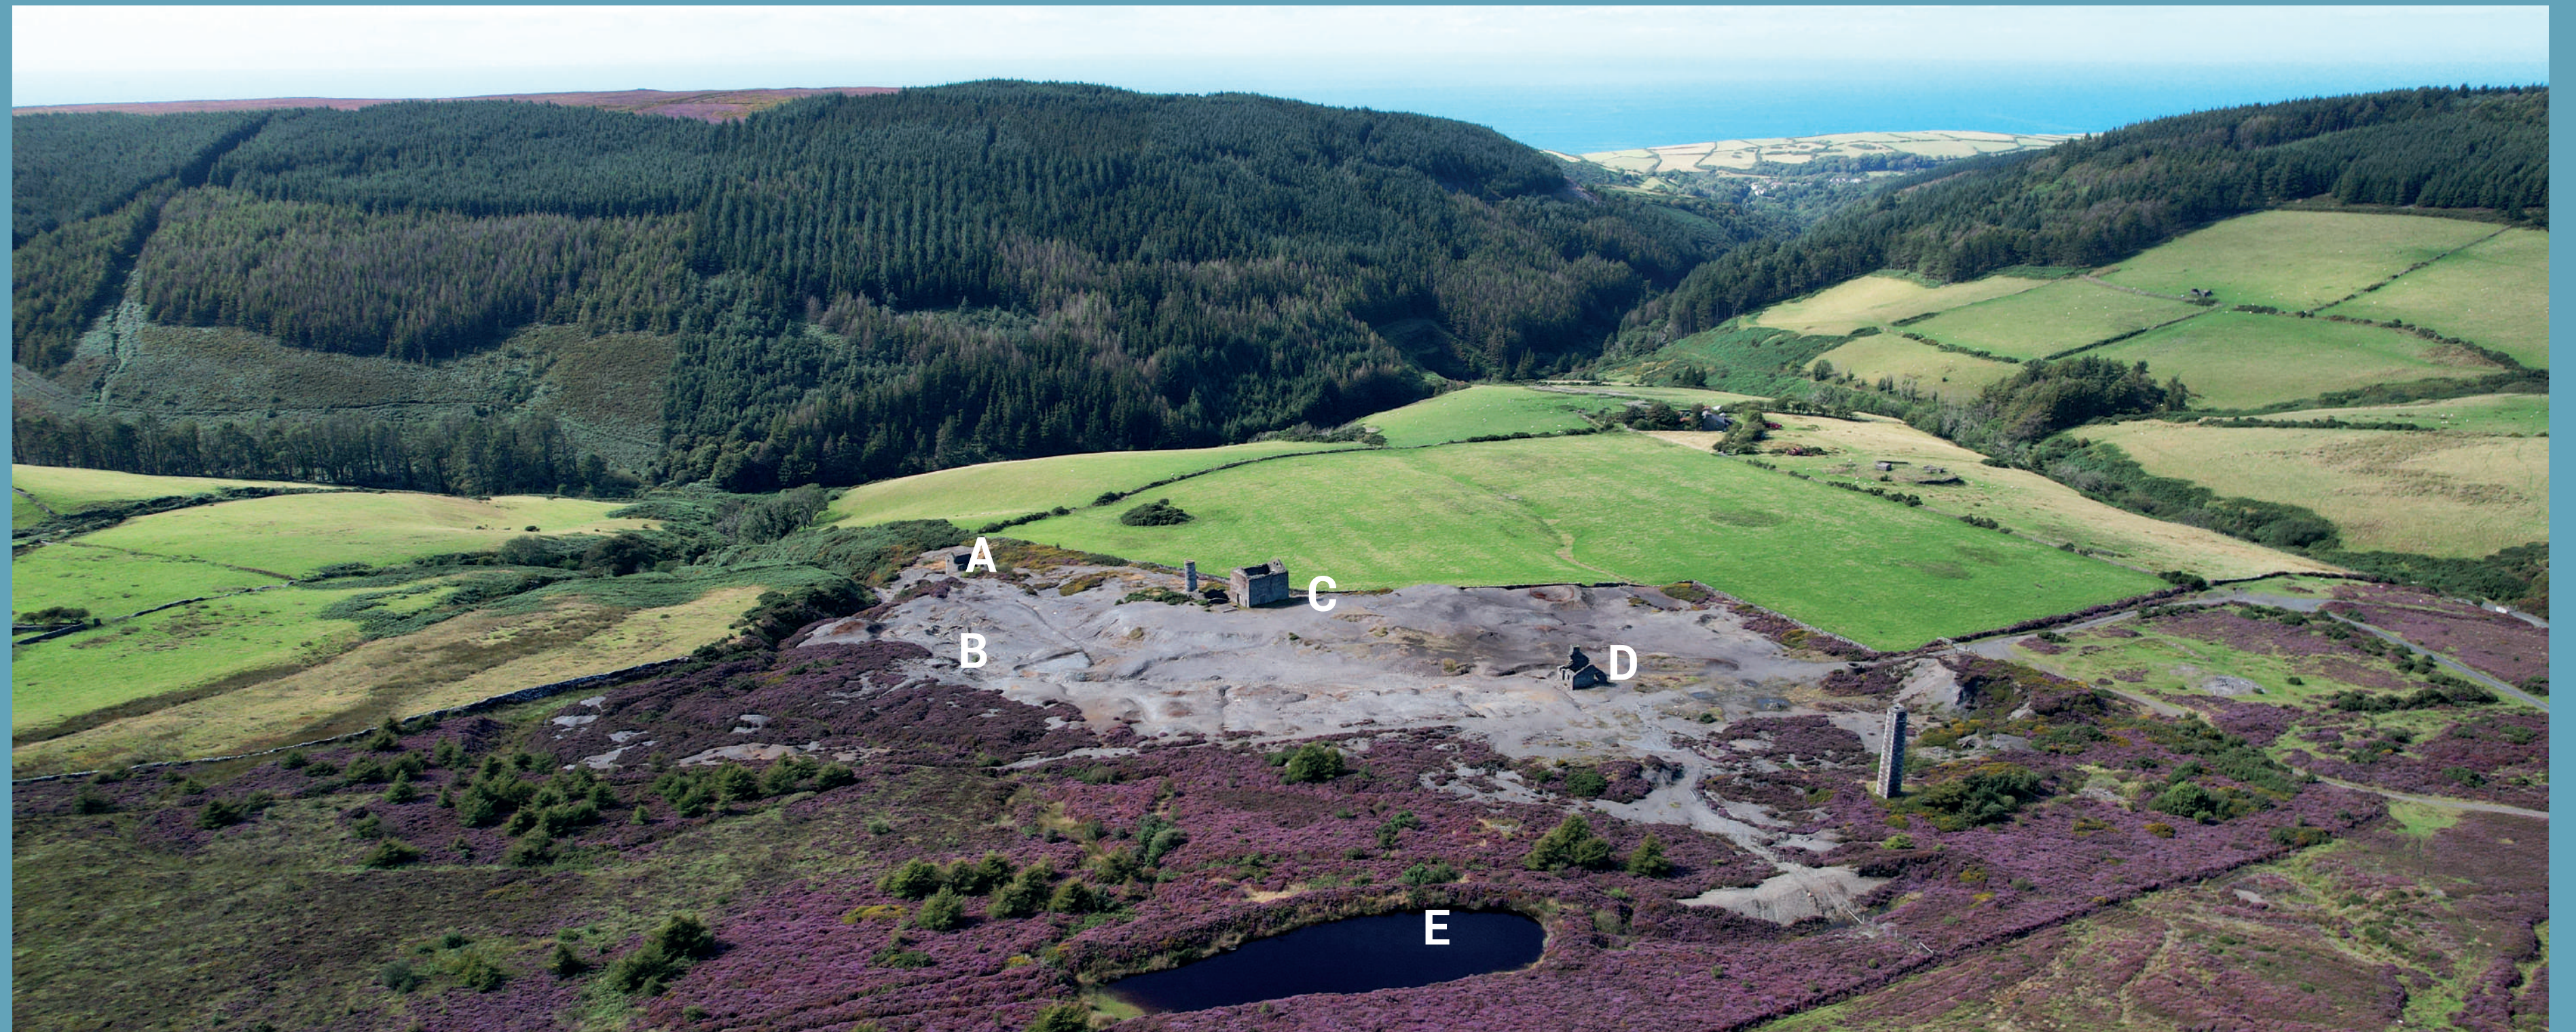
Fig.1—Aerial view of Beckwith's Mine. [Image courtesy of John Wornham, Island Images](#)
A: Stamp House and connected waterwheel, B: Wash floors, C: Engine House and Engine Shaft, D: Mines Office, E: Water supply collected from Valley

During its operation, the Isle of Man Mining Company constructed lades to channel water from the valley above Beckwith's to supply the waterwheels and a dam was built to create a reservoir from which water could be released on demand. The washing floors were developed to house a steam engine and waterwheel for crushing and milling the ore. Produce was crushed in the Stamp House by machinery powered by a waterwheel connected to the building – the casing of which is still visible. The metals were then fed into shallow pits known as rotary 'buddles', in which water was fed through the ore to wash out the lighter waste material, producing pure concentrate.

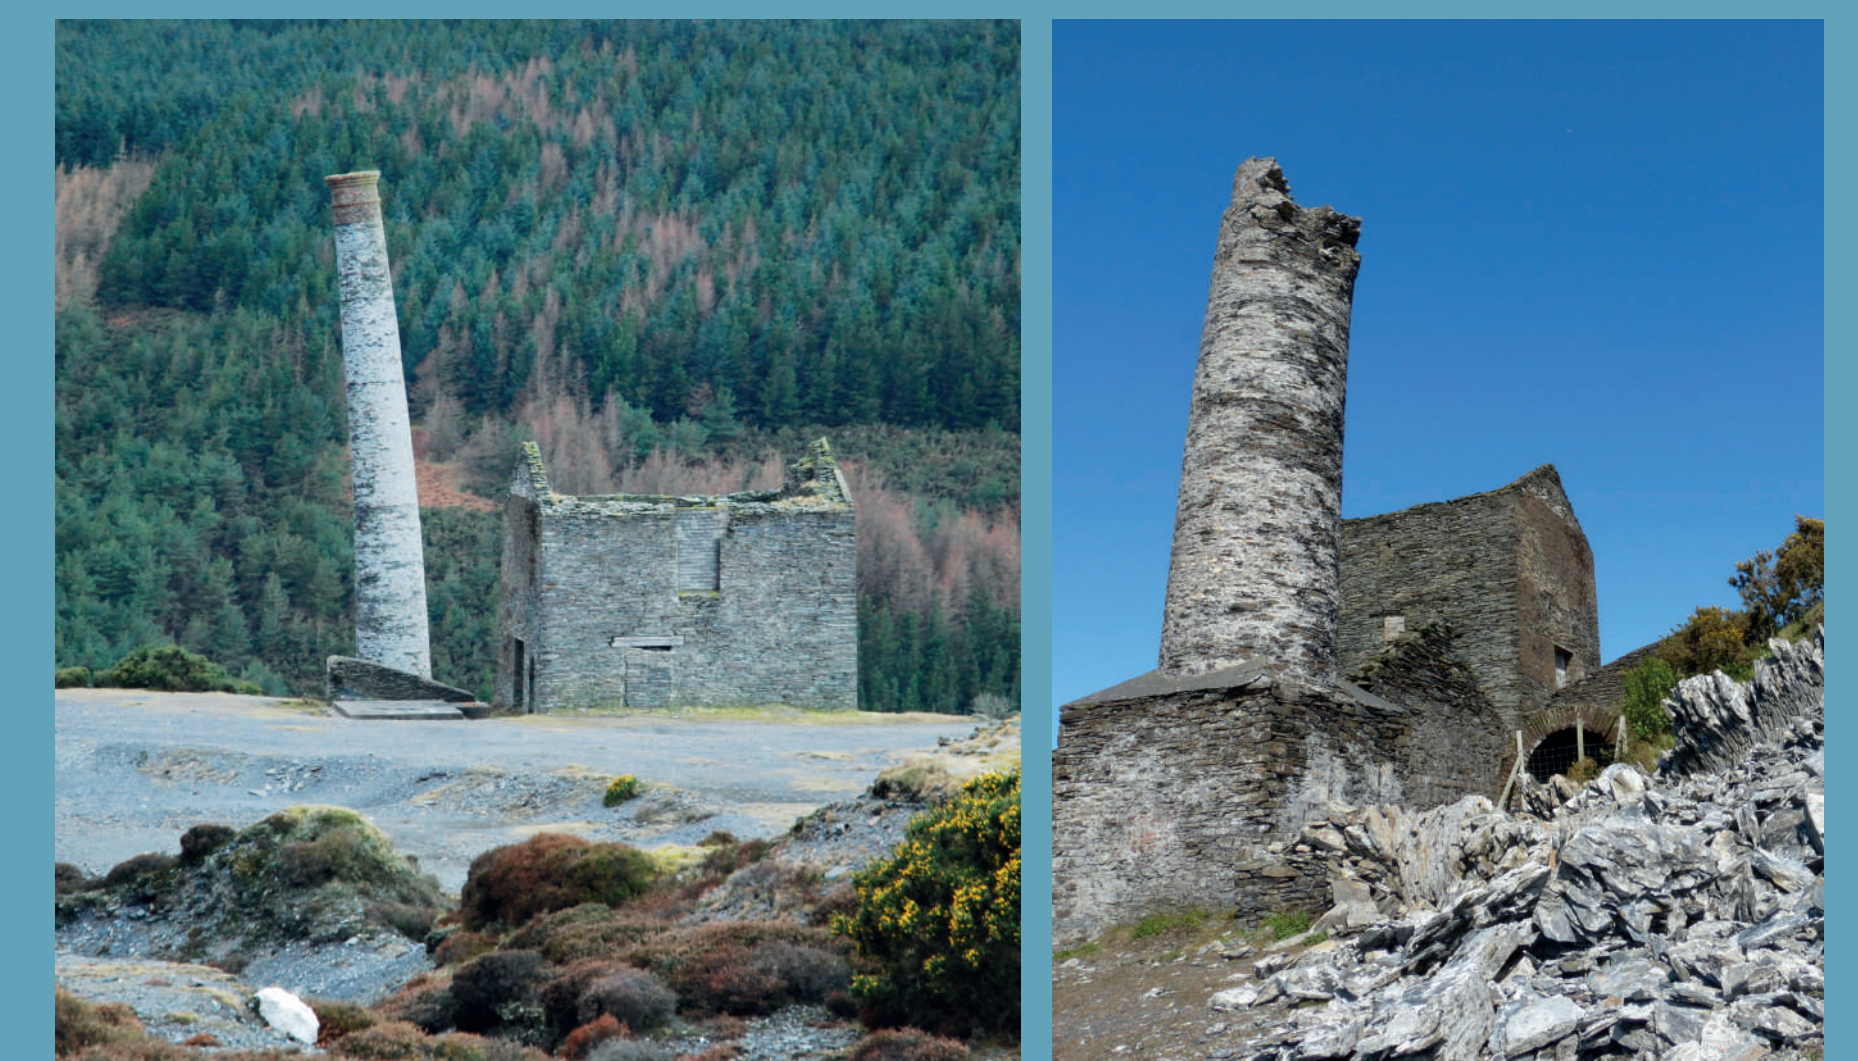
Fig.2—Beckwith's leaning chimney before collapse (left); after collapse (right). [Images courtesy of Manx Scenes \(left\) and Energy FM \(right\)](#)

The surface remains at Beckwith's mine are well preserved. Whilst the capped engine shaft collapsed in 1996, The Laxey Mines Research Group safely consolidated the ruin using a concrete cap. A great leaning chimney dominated the site for 150 years, however, strong winds toppled the structure in April 2012. Only the bottom half of the chimney remains at the engine shaft.
